READ BEFORE

INSTALLING 66B BURNER ASSEMBLY

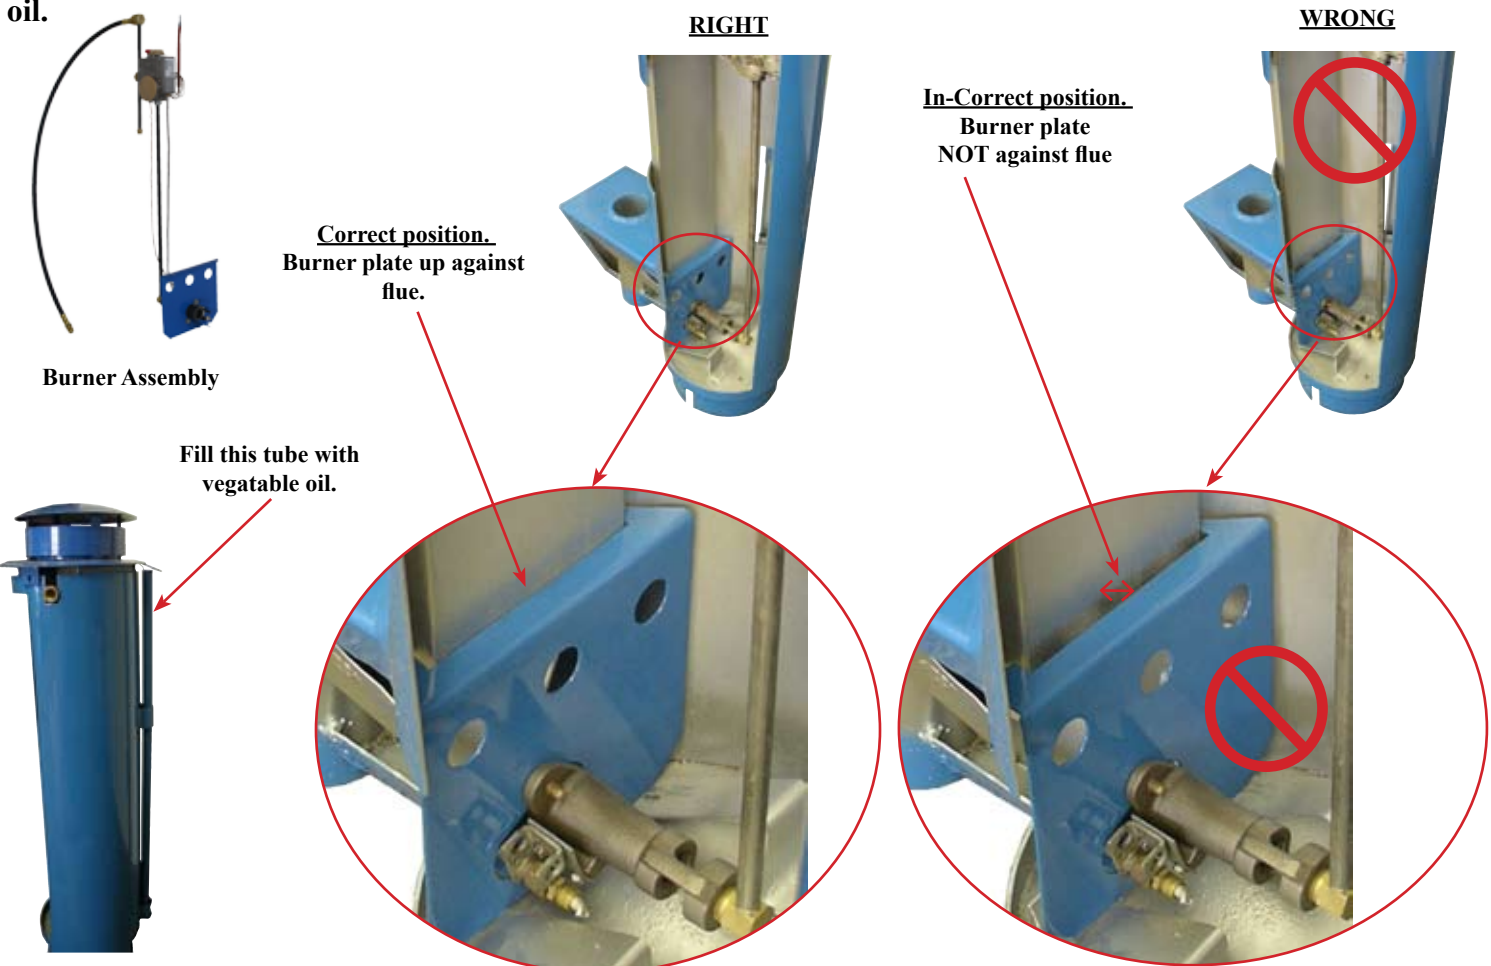
When installing make certain the burner assembly is positioned in the case as shown below. Use a flash light and check inside the casing to verify the plate is positioned properly. **DO NOT** turn the main burner on if the plate is not against the flue properly. Re-position the plate then ignite the burner and make certain the excess heat is escaping from the flue and not entering the main casing.

When installing your 66B Burner Assembly into the heater case make absolutely certain you position the assembly correctly in the case. The burner plate has to be positioned correctly to prevent heat from escaping backwards into the main casing. Wrong positioning could severely damage the unitrol control beyond use and it will then need to be replaced. This type of damage **IS NOT** covered by the Warranty. To prevent this, follow these instructions closely.

If water enters the tube holding the heat sensing bulb from blowing snow or blowing rain and then freezes, it will crush the heat sensing bulb. If this occurs the whole Unitrol unit will have to be replaced. This type of damage **IS NOT** covered by the Warranty. To prevent this from occurring, fill the tube with vegetable oil.
